AVIATION OCCURRENCE REPORT

ARROW AIR INC.
DOUGLAS DC-8-63 N950JW
GANDER INTERNATIONAL AIRPORT,
NEWFOUNDLAND
12 DECEMBER 1985
REPORT NUMBER 85-H50902

28 October 1988

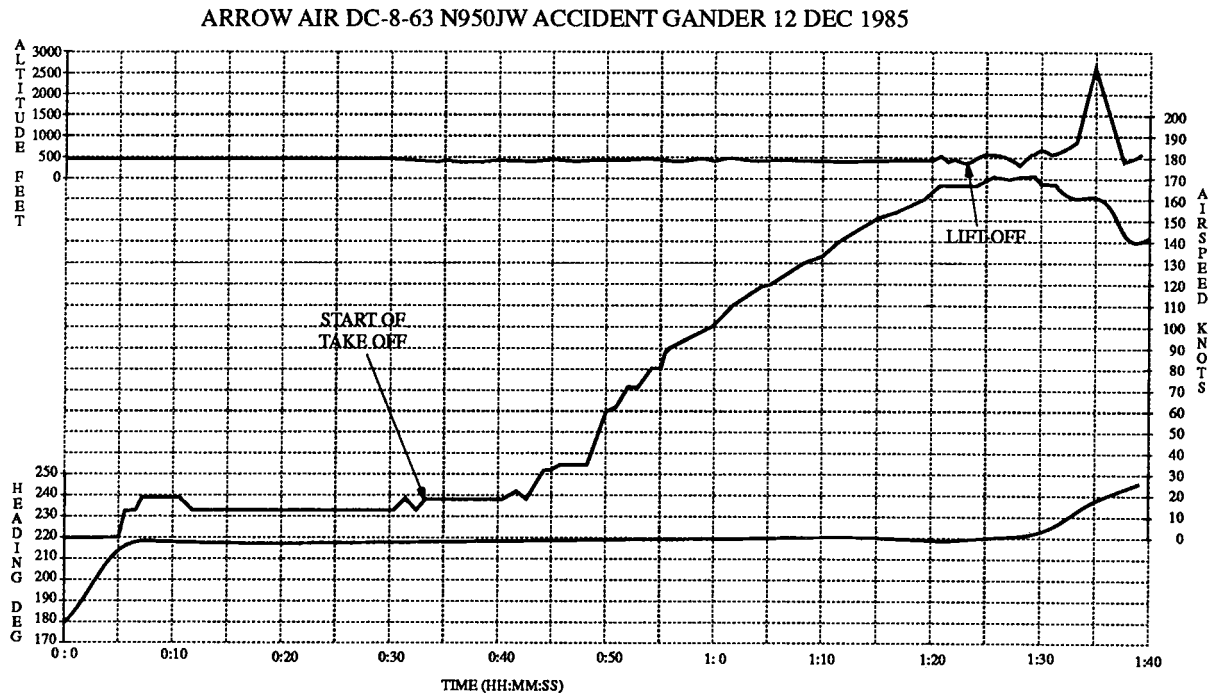
Figure 1.4. FDR Information for Accident Flight

Analysis of the recorded data indicated that the take-off roll commenced at 1015:06. Thereafter, airspeed increased steadily to a peak value of 172 KIAS 53 seconds after commencement of the take-off roll, and then decreased.

Examination of the vertical acceleration trace determined that lift-off occurred about 51 seconds after the commencement of the take-off roll.

Based on integration of the true airspeed with allowance for the reported wind, at 51 seconds after brake release, the aircraft was about 8,000 feet from the starting point of the take-off roll and crossed the end of the runway about 57 seconds after the start of the take-off.

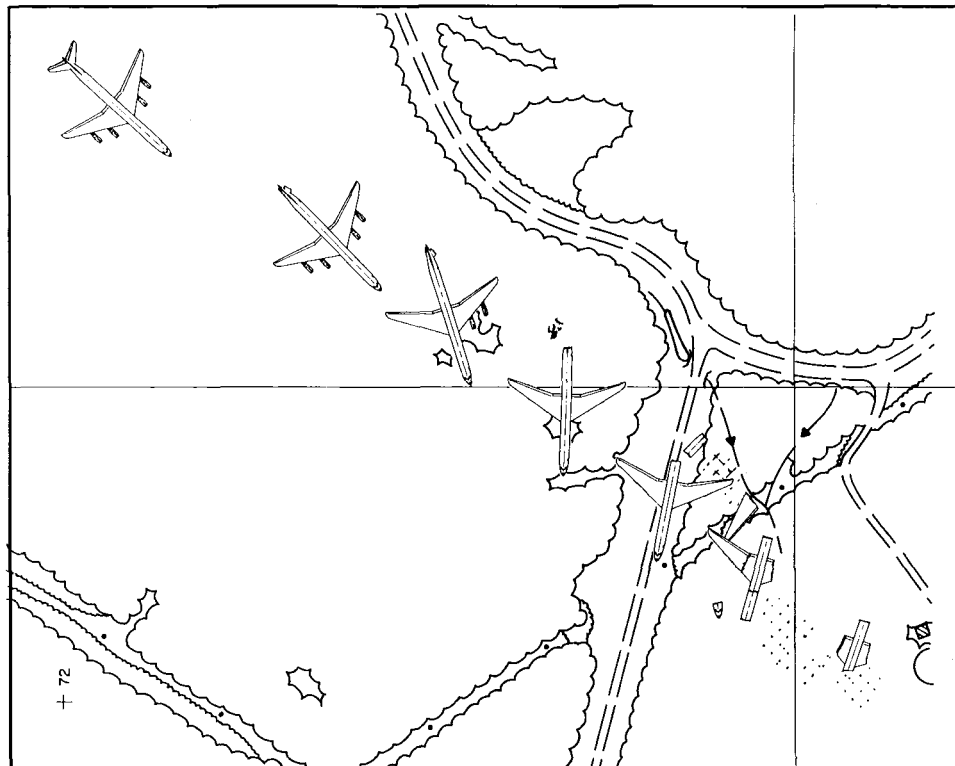
Figure 1.6. Aircraft Breakup Sequence

A thorough search of the runway and the area between the runway end and initial impact point was conducted with the assistance of personnel from Canadian Forces Base Gander. No components or debris was located that could have come from the aircraft. There was no evidence that the aircraft tail had touched the runway during the take-off. (See Figure 1.6.)

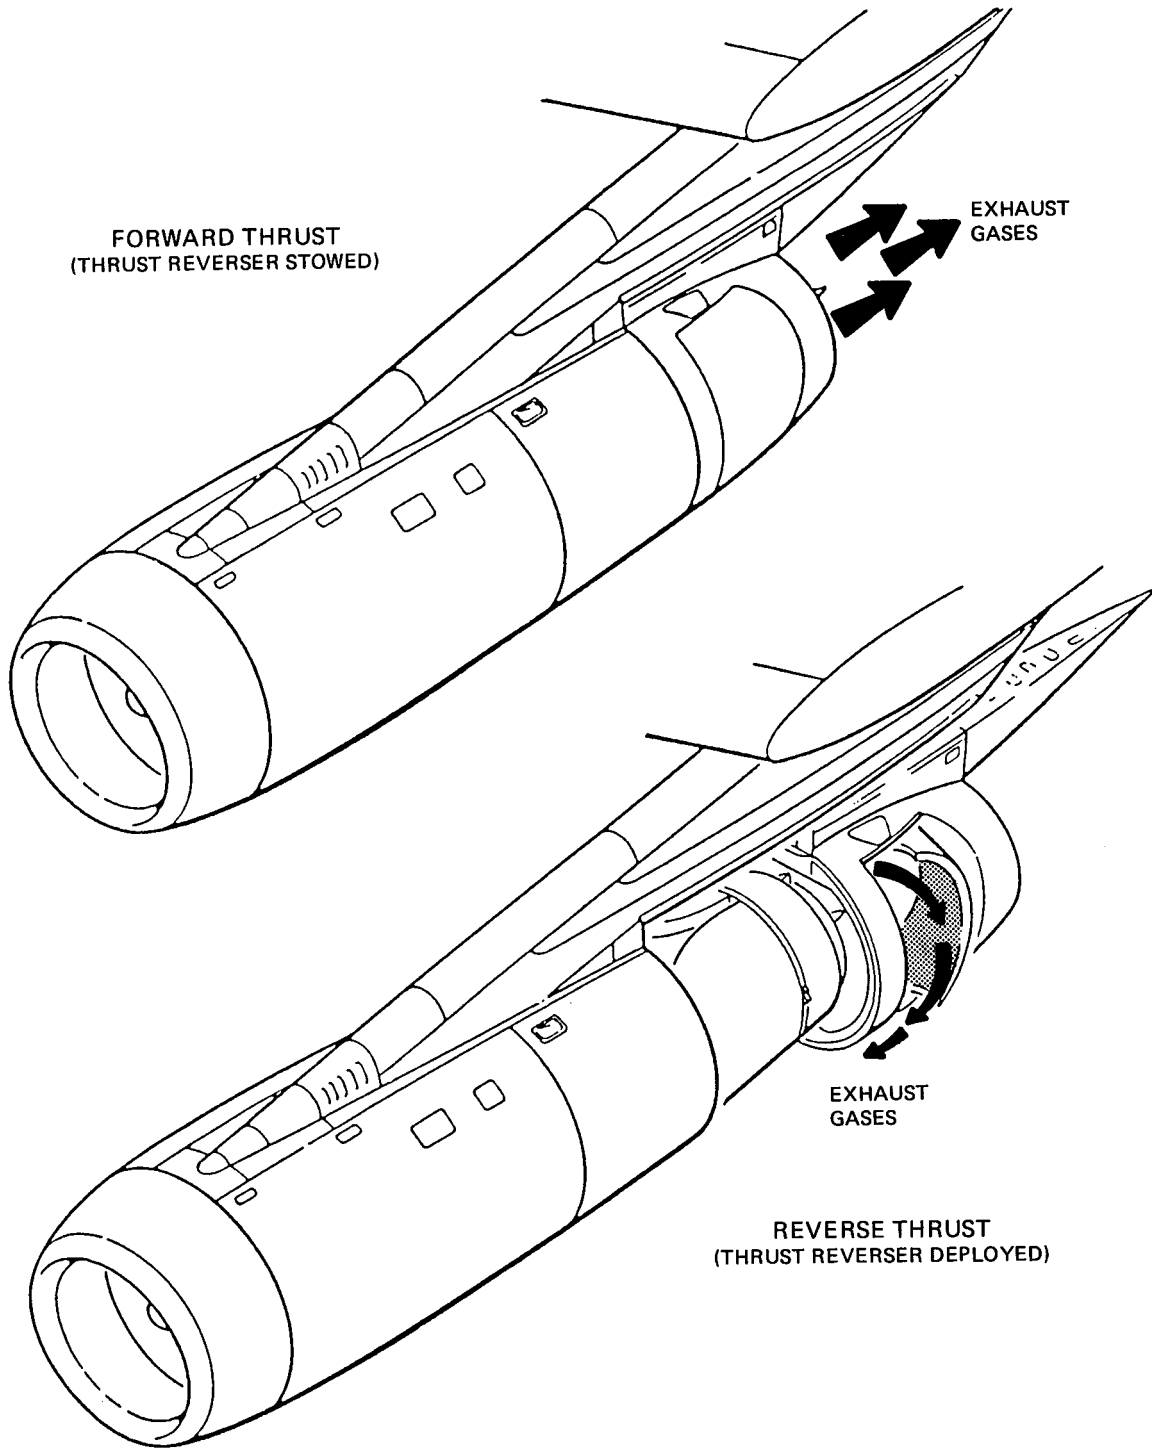
Figure 1.7. Schematic of Thrust Reverser Assembly

The number four reverser assembly had separated from the exhaust nozzle at impact. The forward loop of the translating ring assembly was broken with pieces missing from both sides. The lower deck was twisted 180 degrees around the rear section of the ring so that the forward face of the upper part of the translating ring was at one end of the assembly and the forward face of the lower portion was at the other end. The outboard deflector door was trapped by the structure in the faired position at the lower hinge point. The metal skin in this area was deformed inward, trapping the actuating arm in the faired position. The upper actuating arm for this door was torn away from the translating ring, but there were clear witness marks on the slot edge showing that the arm was in the faired position at the time this damage occurred (Figure 1.8.). The inboard deflector door was torn away from the upper attachment point and was twisted to the deployed position. There was moderate to heavy damage to the forward edge of this door. There were deformed areas to the aft end of the actuating arm slots at both the upper and lower hinge points, evidence that the actuating arms for the inboard deflector door were also in the faired position at impact (Figure 1.9. and Figure 1.10.). The lower track was severely twisted but remained attached by the slide bracket to the forward edge of the translating ring. The slide was within 12.5 inches of the forward position and could not have slid forward after this impact deformation had occurred (Figure 1.11.). The hydraulic actuator was near the forward end of the piston rod. The outer cylinder had split lengthwise, with the material around the split bowed out (Figure 1.12.). This evidence was consistent with rapid extension of the actuator by external forces, and further confirmed that the translating ring had been in the forward position at the time of ground impact. It was concluded that the number four reverser was in the faired position with the translating ring in the forward (stowed) position at ground impact.

No failures were noted in any of the four reverser systems other than those resulting from impact.

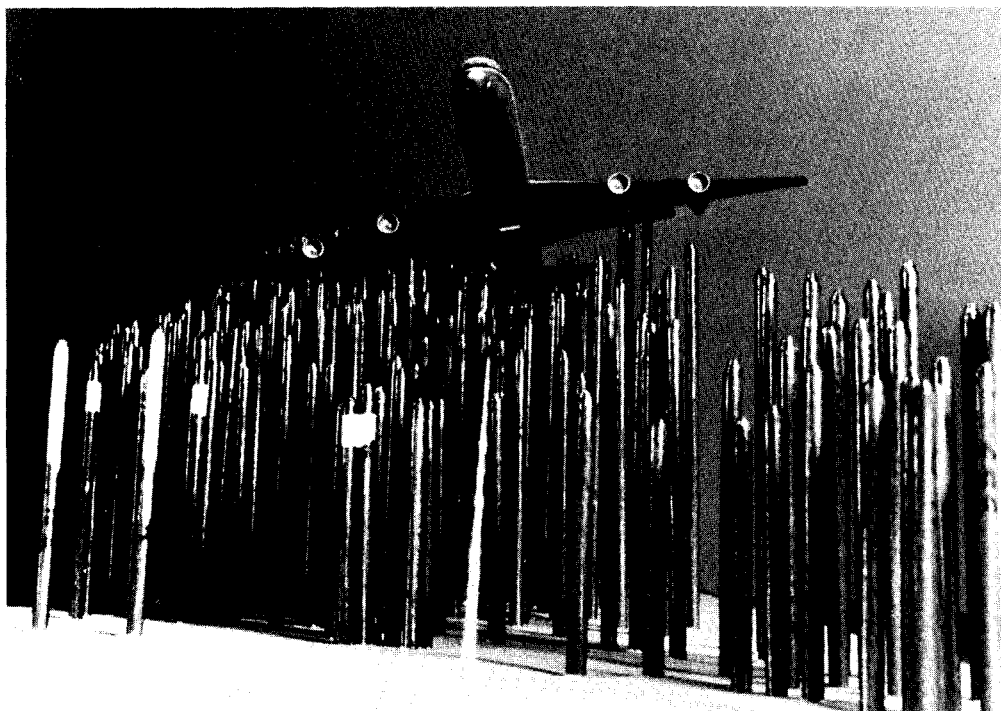
Figure 1.14. Reconstruction of Impact Attitude

Using analytical plotters, three dimensional measurements were made of 378 trees which had been cut by the aircraft prior to ground impact (See Figure 1.13.). A 1/100 scale model of the tree-cut zone was then constructed, and a detailed 1/100 scale die cast model of a Douglas DC-8-63 aircraft was mated to the tree pattern (See Figure 1.14.). Flaps were placed on the model at an 18-degree configuration to match post-crash investigation findings. By accurately measuring the orientation of the aircraft model in the tree pattern at increments along its flight path, the attitude of the aircraft and the flight path angle were determined. Measurements indicated that the aircraft first contacted the tree canopy in a seven-degree right bank, nine-degree pitch (the angle between the longitudinal axis of the fuselage and the horizontal), and a 10-degree yaw right attitude, on a descending, 12-degree flight path angle (the angle between the flight path and the horizontal).

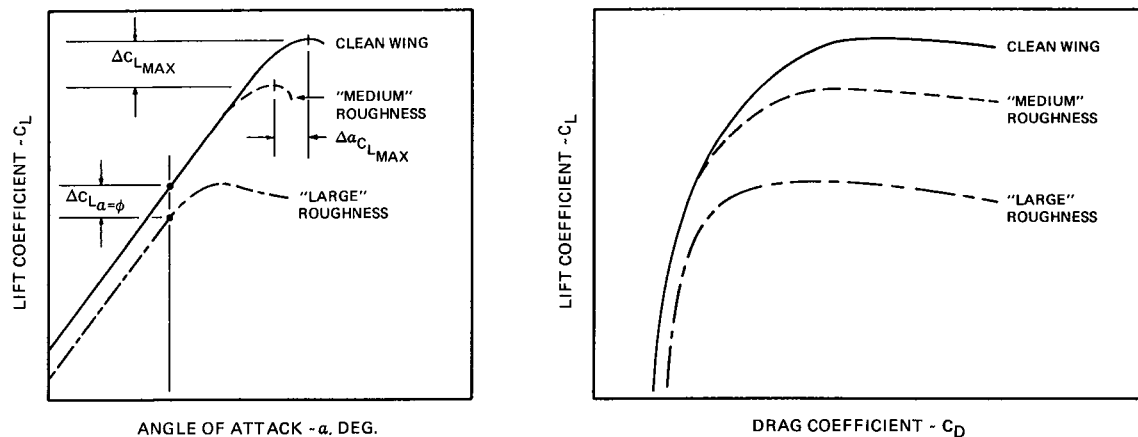
Figure 1.15. Typical Effect of Surface Roughness at the Leading Edge on Aerodynamic Characteristics

Considerable research has been conducted into the effects of ice contamination on airfoil performance. As a result of this research, it is accepted that, in general, ice accretion on the leading edge or upper surface of an aircraft wing results in an increase in stalling speed, decrease in the stall angle of attack, and rapid drag increase near the stall. (See Figure 1.15.)

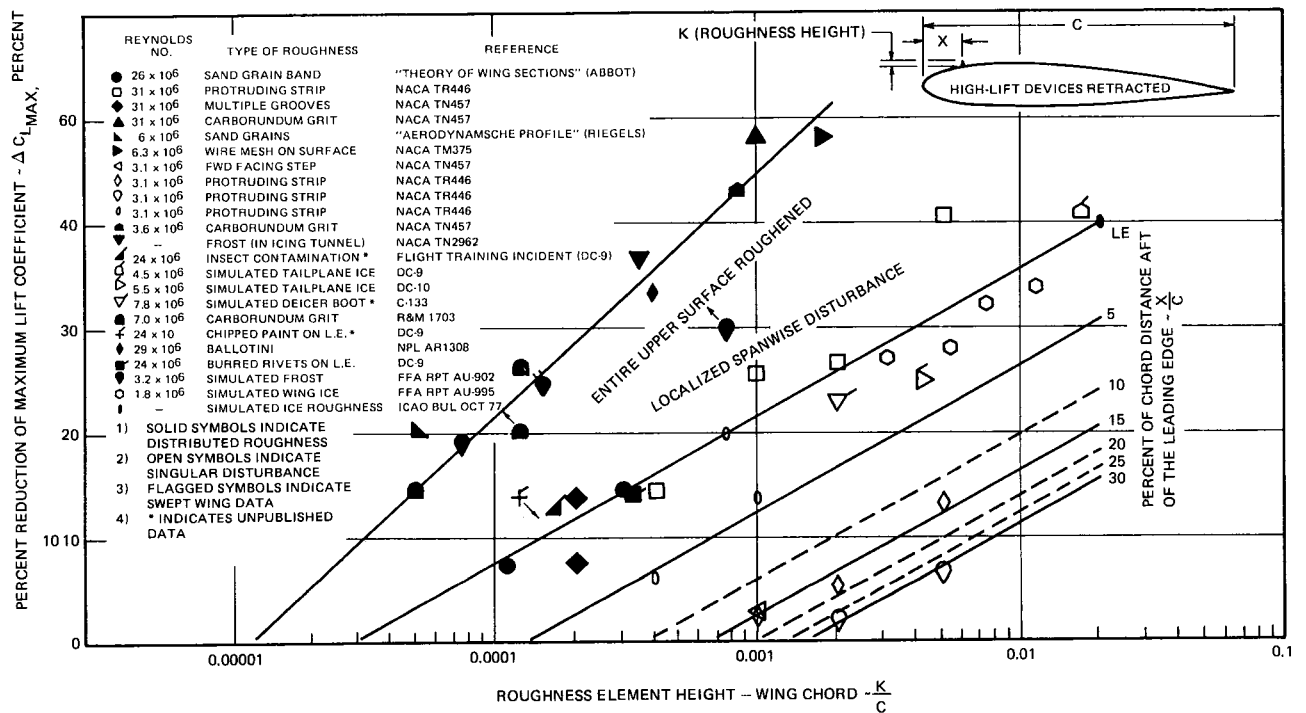
Figure 1.16. Reduction of Maximum Lift Coefficient Due to Wing Surface Roughness

Data provided by Douglas Aircraft enabled the Board to estimate the decrease in coefficient of lift maximum which would result from the calculated leading edge accretion amounts. As seen in Figure 1.16., the per cent reduction of maximum lift coefficient which results from a localized, spanwise disturbance or narrow band of roughness located at the leading edge is a function of the roughness height divided by chord length.

From Figure 1.16. it can be seen that the reduction of maximum lift coefficient determined at the 85, 53, and 26 per cent semi-spans equates to full upper surface contamination with roughness elements of 0.052 inches, 0.033 inches, and 0.022 inches respectively.

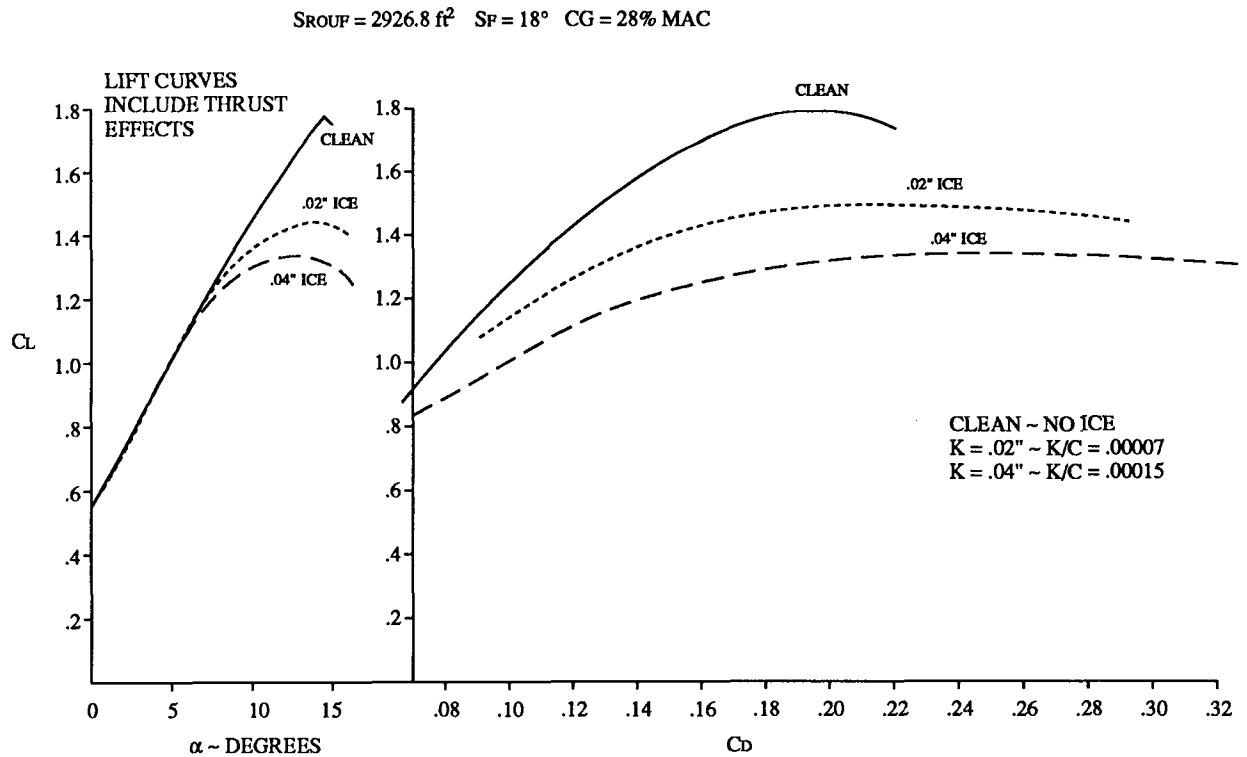
Figure 1.17. Model DC-8-63 Effect of Wing Upper Surface Distributed Roughness on Aircraft Lift and Drag

The lift penalty which results from closed wing slot doors is a 0.2 reduction in maximum coefficient of lift. Ground spoiler deployment results in a 0.4 reduction in coefficient of lift at zero degrees angle of attack. This reduction increases as angle of attack increases. Douglas Aircraft Co. was unable to provide exact data for higher angles of attack. With respect to ice contamination, Douglas Aircraft Co. supplied information which indicated that, with wings contaminated by surface roughness elements of 0.04 inches, maximum coefficient of lift would be reduced by about 25 per cent. The coefficient of drag at or beyond the stall angle of attack (which would be a lower than normal angle) would increase by greater than 100 per cent relative to an uncontaminated wing operating at the same angle of attack, below the stall. (See Figure 1.17.)

Unlike the Boeing 737, the Douglas DC-8-63 is not equipped with wing leading edge devices. Douglas Aircraft Co. confirmed that the performance degradation experienced by the DC-8-63 with small amounts of contamination is significantly greater than that encountered by other aircraft types equipped with leading edge devices. Information provided by the Douglas Aircraft Co. indicated that significant reduction in the maximum coefficient of lift and significant increase in the coefficient of drag would be experienced with surface roughness elements of 0.04 inches. (See Figure 1.17.)
